REPORT

Of an Ad Hoc Investigation Committee appointed in November 2002 to investigate an aircraft accident in the inlet of Skerjafjörður on 7 August 2000

REYKJAVÍK 2003-05

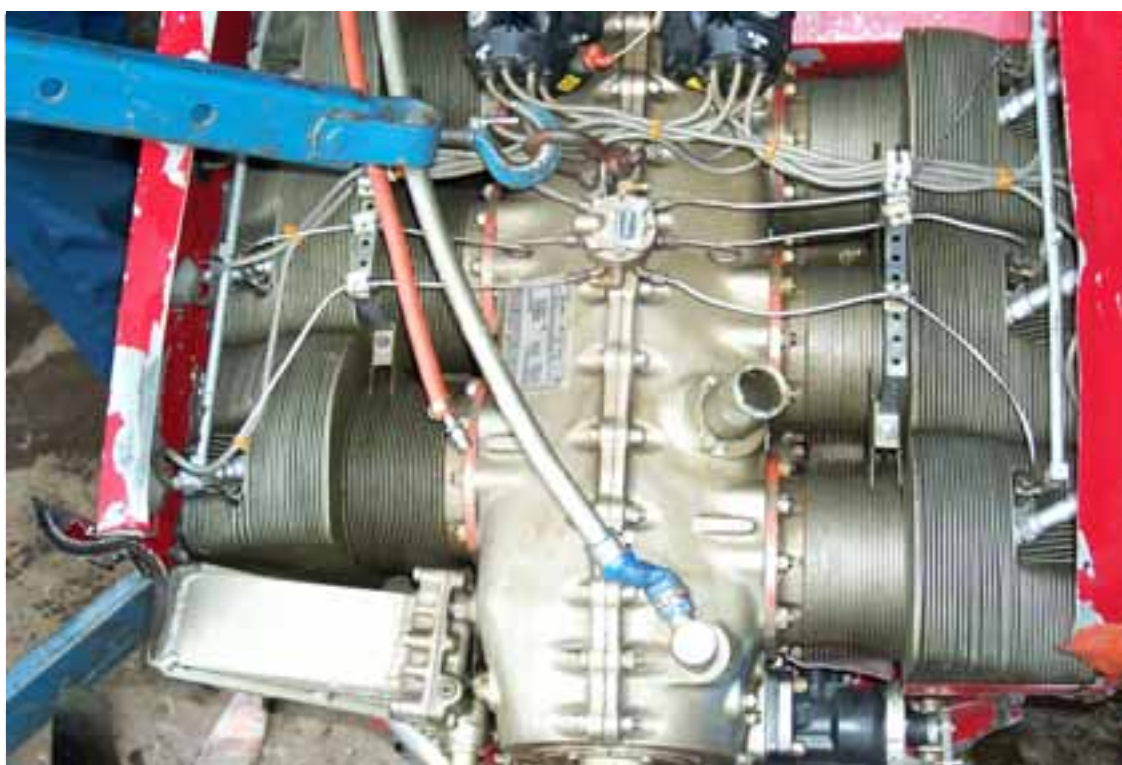
The photograph shows the aircraft's engine The oil cooler is on the left side in the photograph in front of cylinder No. 5 which confirms that the engine is a type H

The AAIB and Teledyne Continental claim that this is the same engine as the one that was overhauled at Gold Star Aviation Accessories. The aircraft's flight time according to the log book on 16 September 1994 and the JAS, Inc. maintenance certificate of 15 June 1999 which both show 3390.0 hours supports that conclusion. Furthermore, it is worth mentioning that none of those who have inspected the engine seem to have made any objections, which they must have done if it had been an E-type and not a correct type for a Cessna T210L. The next Section will treat of whether an E-type was changed to an H-type.

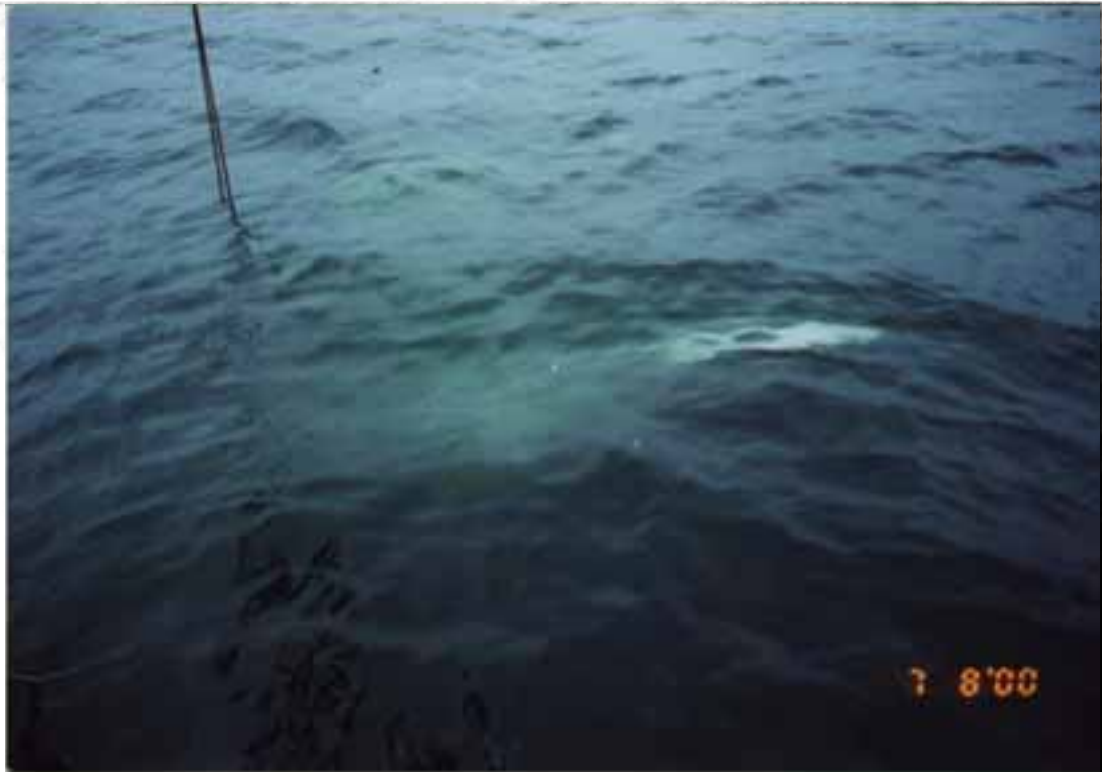
The picture shows clearly that oil came up along the wires that were used to lift the wreck from the sea and a slick has formed.

The pictures of when the wreck was salvaged that have been presented to the Ad Hoc Investigation Committee and are shown here, indicate clearly that oil came up with the wires used to lift the wreck from the sea. The slick was directly over the wreck. Even though it cannot be confirmed whether the oil was from the aircraft's engine or from a barge used for hoisting the wreck to the surface it must be considered very likely that it came from the engine, as it is unlikely that such a quantity leaks from a barge or ship while in use and men are working.

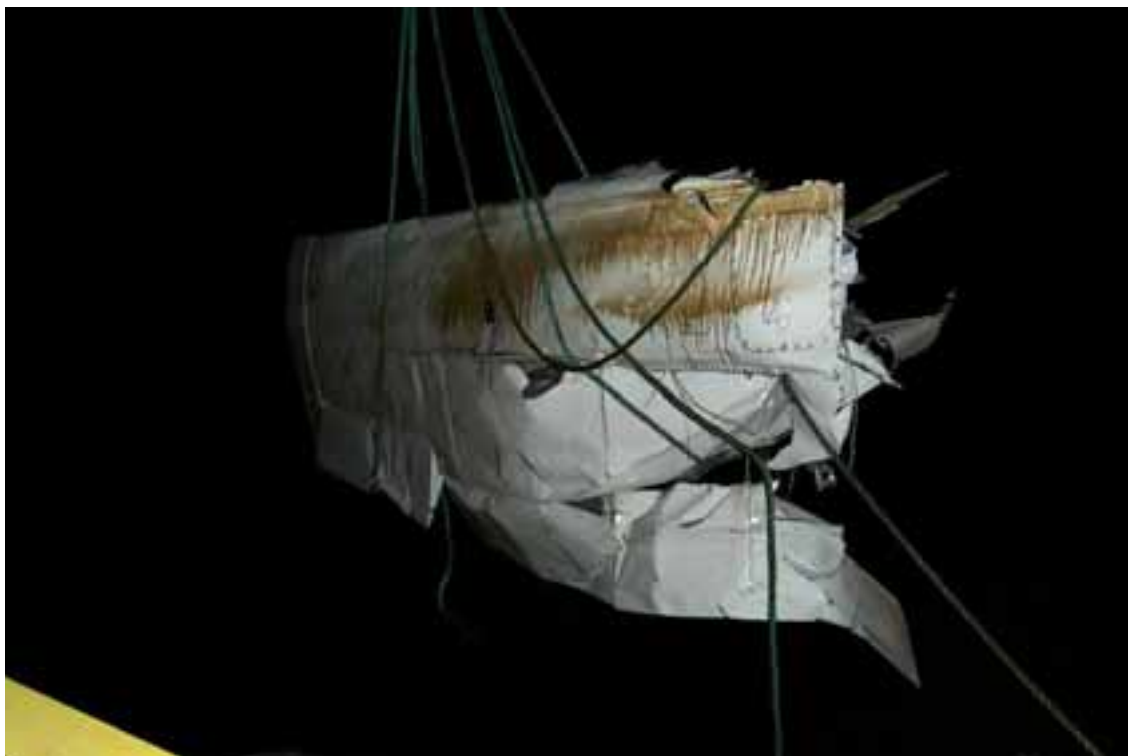
This picture shows considerable oil on the aircraft's wing which is being lifted up. It shows beyond doubt that there was no oil on the wing while it was flying, but that it came onto the wing as it was lifted from the sea. These two pictures do not indicate any oil depletion in the engine.

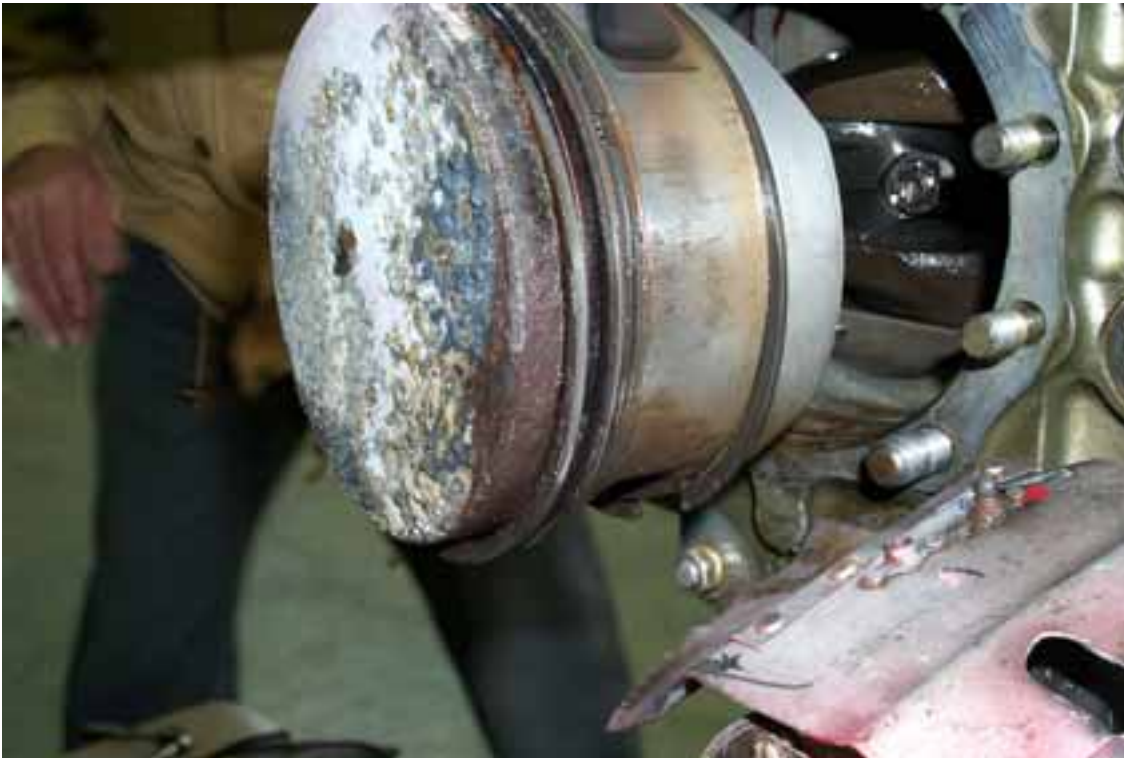
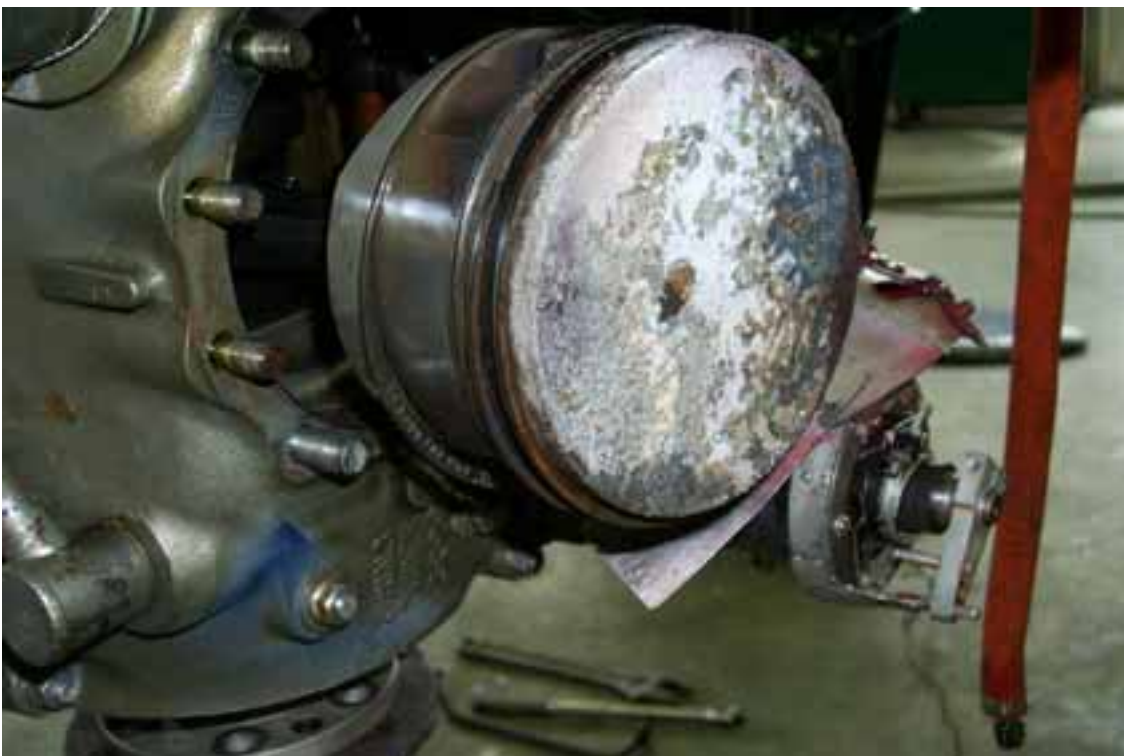
For further confirmation thereof are these pictures of a piston from one of the cylinders that were opened when the engine was investigated. They show no damages, on the contrary - the cylinder is smooth and shining.

These two pictures show no damages in the engine's pistons which would have had to be if it had seized.

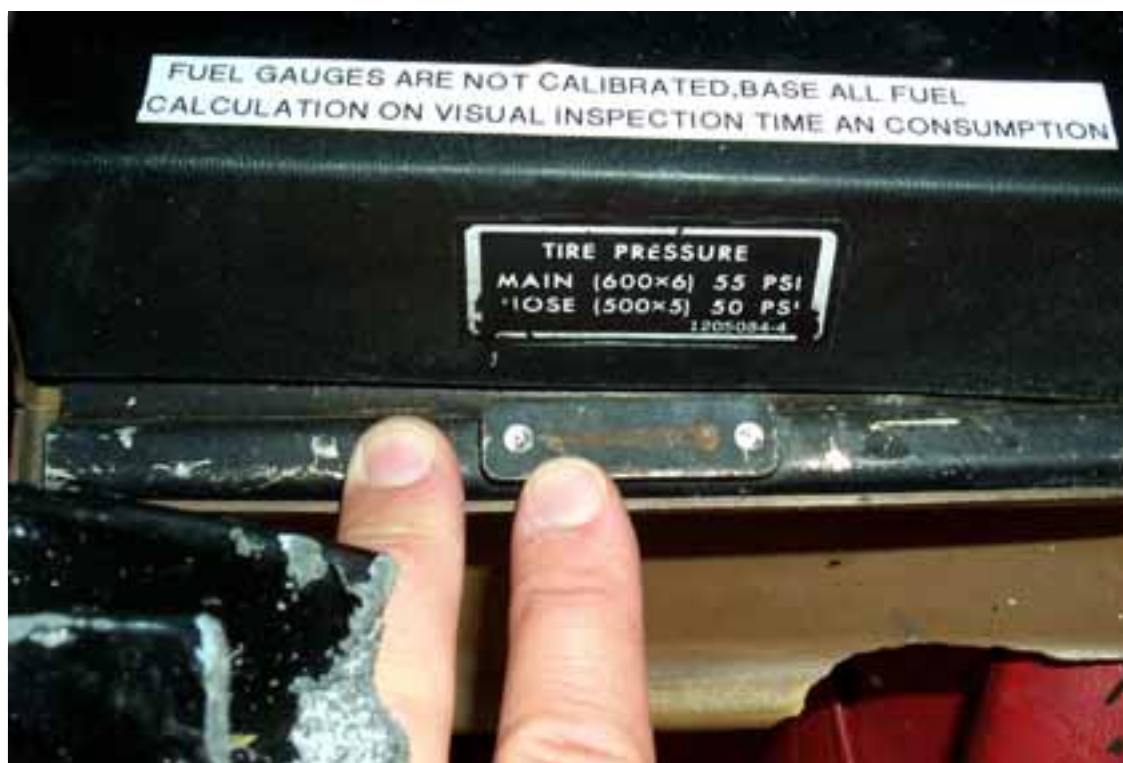
No indications of other markings were found in or on the wreck. As can be seen on the picture beneath, the latter part of the text is missing on the placard on the instrument panel of the aircraft.

The picture shows the placard on the aircraft's instrument panel.

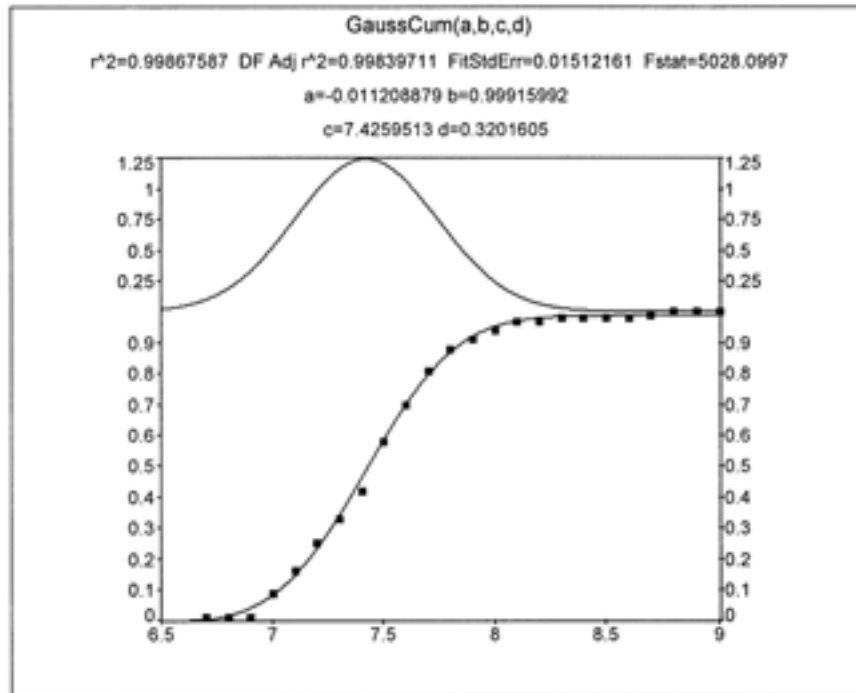
Figure 5-5. Likelihood of fuel starvation as a function of time without the wing-end tanks and no additional fuel consumption due to the gear down.

The mean value in the distribution is 7.42 hours which is the most likely point in time that the aircraft would have fuel starvation. The cumulative likelihood at that time is 50%. As previously described there is 94% likelihood that the aircraft had fuel starvation at the time of accident.

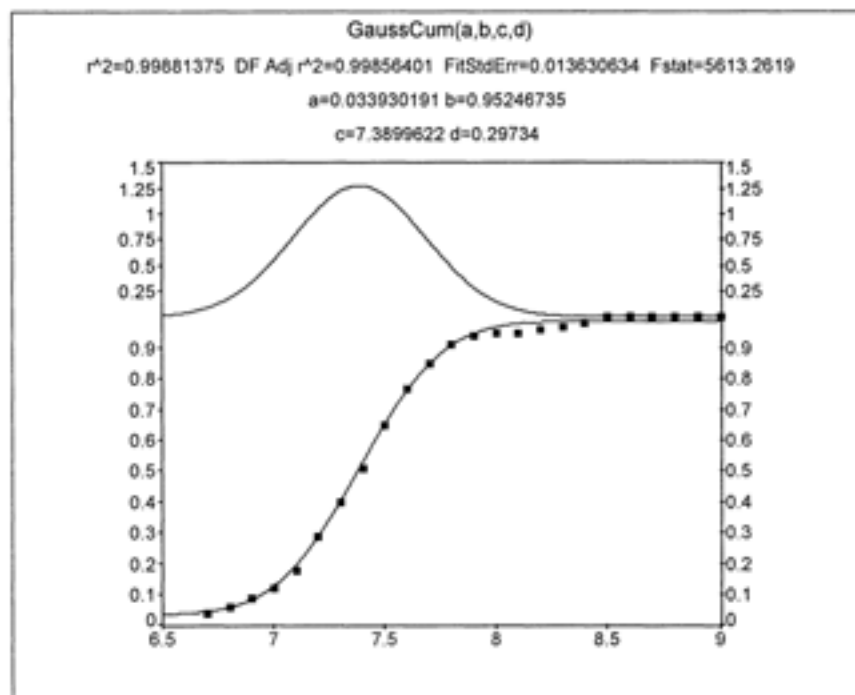
Figure 5-6. Likelihood of fuel starvation as a function of time without the wing-end tanks and additional fuel consumption due to the gear down.

It can be seen that the mean value of the distribution has moved to an earlier point in time i.e. 7.39 hour. This is due to more fuel consumption with the gear down. In addition to that it can be seen that the standard deviation has increased somewhat which is caused by the increased variance in the added fuel consumption which adds to the total variance. The likelihood of fuel starvation is 97% when the accident occurred.

It can be seen from Figures 5-5 and 5-6 and Table 5-3 that the likelihood of fuel starvation at the time of accident if the wing-end tanks would not have been used are 94-97%. The effects of adding fuel consumption due to having the gear down on two legs adds 3% likelihood at the time of the accident.
