REPORT

Of an Ad Hoc Investigation Committee appointed in November 2002 to investigate an aircraft accident in the inlet of Skerjafjörður on 7 August 2000

REYKJAVÍK 2003-05

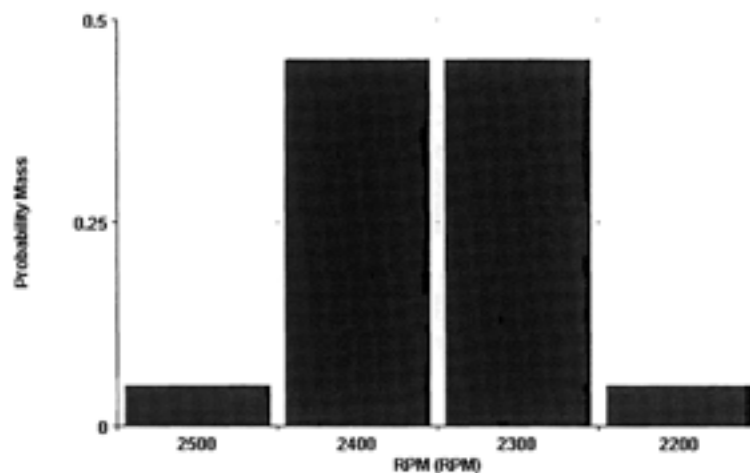
Figure 4-2. Statistical distribution of RPM.

This statistical distribution was based on pilot experience. It was thought to be most likely that the aircraft was being operated at 2400 RPM or 2300 RPM but it was difficult to say which one was used. In addition to that it was thought to be unlikely that the aircraft was being operated under 2300 RPM and it is rare that aircraft are being operated at full power.

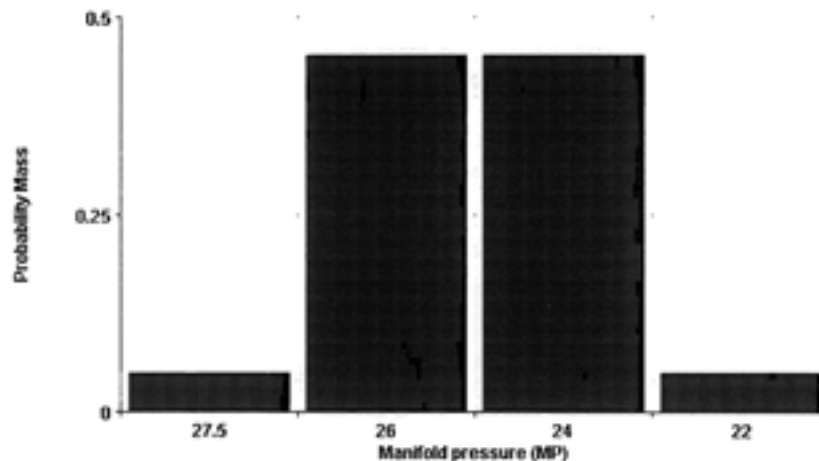
Figure 4-3. Statistical distribution of the manifold pressure.

This statistical distribution was based on pilot experience. It was thought to be most likely that the aircraft was being operated at 26 MP or 24 MP but it was difficult to say which one was used. In addition to that it was thought to be unlikely that the aircraft was being operated under 24 MP and it is rare that aircraft are being operated at full power.

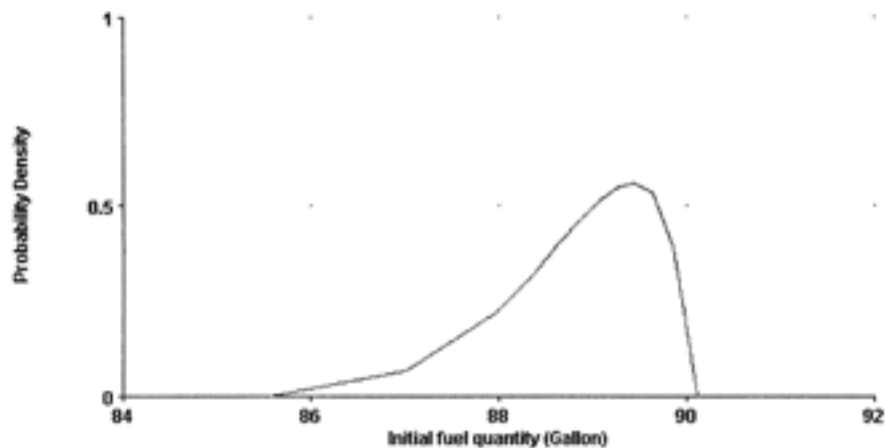
Figure 4-4. Statistical distribution of the initial fuel in the main tanks of the aircraft.

Bull considers it more probable, concerning figure 4-4, page 13 "Statistical distribution of the initial fuel in the main tanks of the aircraft," that the top of the curve should be further to the left. It is his opinion that it is most likely that there were 320 litres of usable fuel in the main tanks before first flight (cf. F and T's report).³

This distribution was chosen in accordance with the special procedures required to fill the main tanks and the maximum fuel capacity.

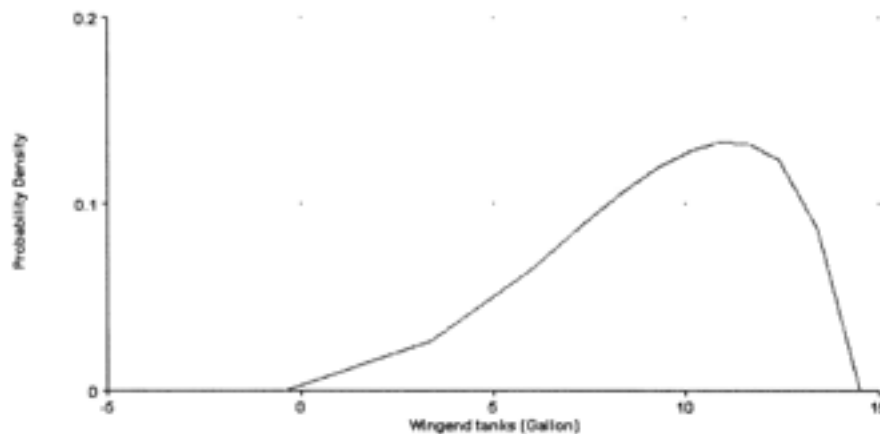
Figure 4-5. Statistical distribution of the fuel quantity in the wing-end tanks of the aircraft.

Concerning Figure 4-5, page 13, "Statistical distribution of the fuel quantity in the wing-end tanks of the aircraft", Bull believes that there were only some very few litres of fuel in the aircraft's wingtip tanks. He does not believe that the pilot succeeded in moving the transfer switch and open up for fuel. If he had managed to open, it is unlikely to have been of use due to the aircraft's attitude, which would have had to have been in level flight (and flown without slip) in order for fuel to feed from the wingtip tank (especially if they only contained a few litres of fuel). Another possibility is that there was some water in this wingtip tank, if it had not been drained for a long time.

This distribution was selected based on the fact that 14 USG was the minimum required fuel and nothing suggests that there would have been more fuel on them. It was also possible that there was no fuel in the tanks although it was unlikely.

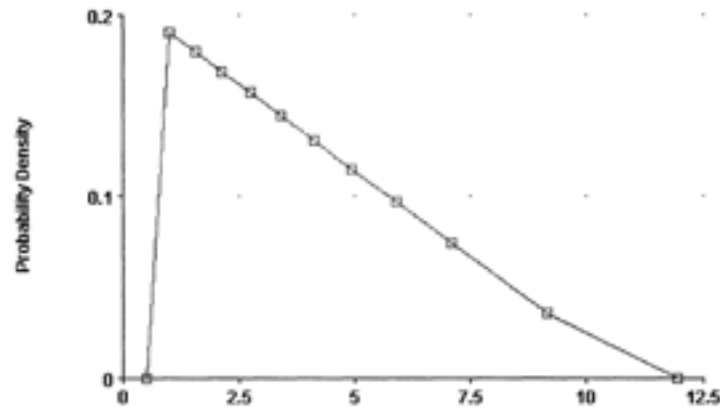
Figure 4-8. Statistical distribution of the minimum required fuel (USG).

Concerning figure 4-8, page 15, "Statistical distribution of the minimum required fuel" Bull believes that the probability of fuel starvation is already great when there are only 2-3 USG in the main tank in use (instead of a reference of 0.75 USG). He refers to his experience of flying C-210 aircraft with the powerful 285-300 hp engine saying that it requires a lot of rudder compensation for a coordinated flight. Everything happened very fast on TF-GTI's go-around. The pilot had flown for a long time that day and may have been late in reacting . Furthermore, a pilot must be very skilled to fly a C-210 aircraft coordinated all the time after he had to abort the landing.

This distribution was in accordance with the information given in the Cessna Pilot Safety Supplement where it states that with less than 11 USG in the main tanks uncoordinated flight can cause fuel starvation of the engine. The lower limit of the distribution was selected in accordance with the minimum usable fuel.

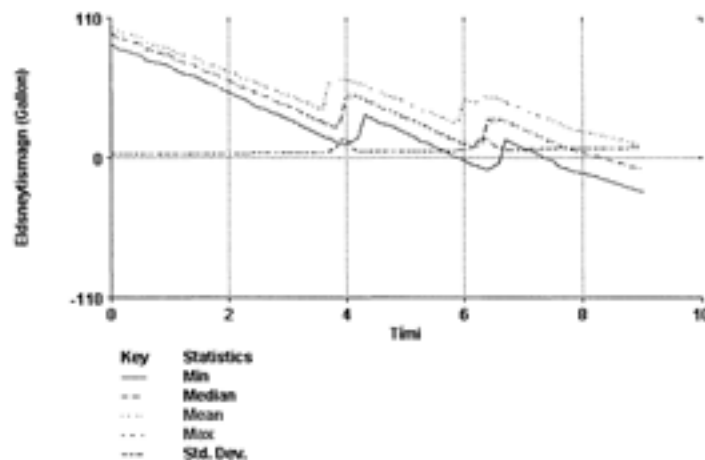
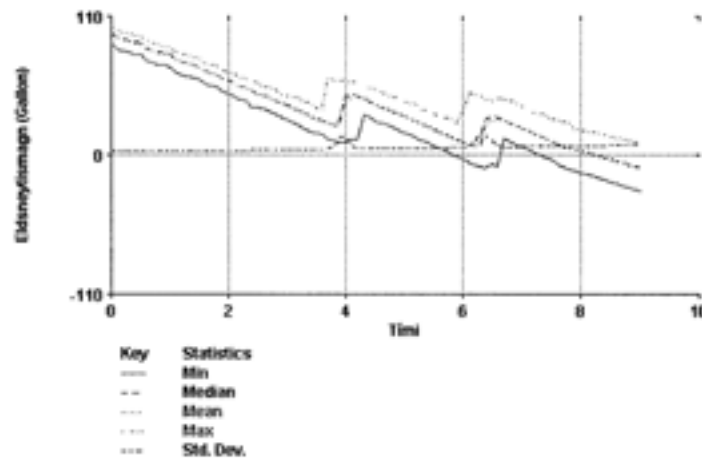
Figures 5-1 and 5-2 show how the fuel quantity changes with flying time if the usage of the wing-end tanks is included and the effects of the gear being down is not included. It can be seen how the added fuel after leg 11 and 18 lift the estimated fuel quantity at around 4 hour and 6.5 hours. It can also be seen how the standard deviation increases with time and that the gap between maximum and minimum values widens as time progresses. The fuel quantity at the last fill up is low.

Figure 5-1. The fuel quantity at a given point in time with the wing-end tanks and no added fuel consumption due to the gear being down. The green color shows the maximum value, the blue the mid value, the pink the mean value, the red the minimum value and the black the standard deviation.

Figure 5-2. The fuel quantity at a given point in time with the wing-end tanks and added fuel consumption due to the gear being down. The green color shows the maximum value, the blue the mid value, the pink the mean value, the red the minimum value and the black the standard deviation.

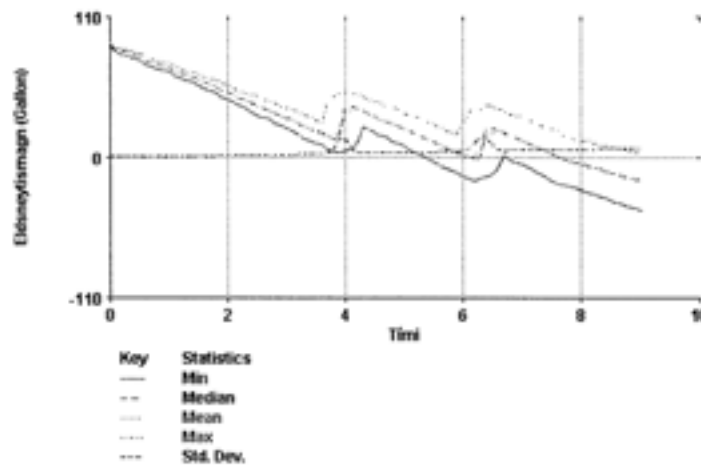
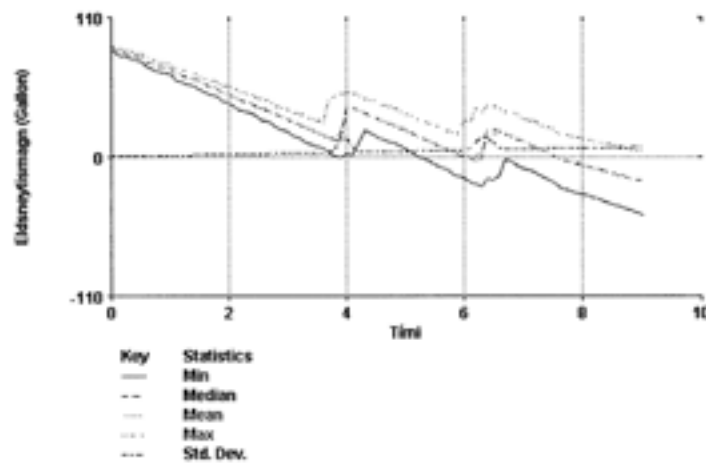
Figures 5-3 and 5-4 show similar information as Figures 5-1 and 5-2 but without the wing-end tanks being used. It can be seen that the fuel quantity is lower and at the time of the last fill up the mean quantity is close to zero. The mean value crosses the zero axis between 7.6 and 7.7 hours.

Figure 5-3. The fuel quantity at a given point in time WITHOUT the wing-end tanks and no added fuel consumption due to the gear being down. The green color shows the maximum value, the blue the mid value, the pink the mean value, the red the minimum value and the black the standard deviation.

Figure 5-4. The fuel quantity at a given point in time WITHOUT the wing-end tanks and added fuel consumption due to the gear being down. The green color shows the maximum value, the blue the mid value, the pink the mean value, the red the minimum value and the black the standard deviation.

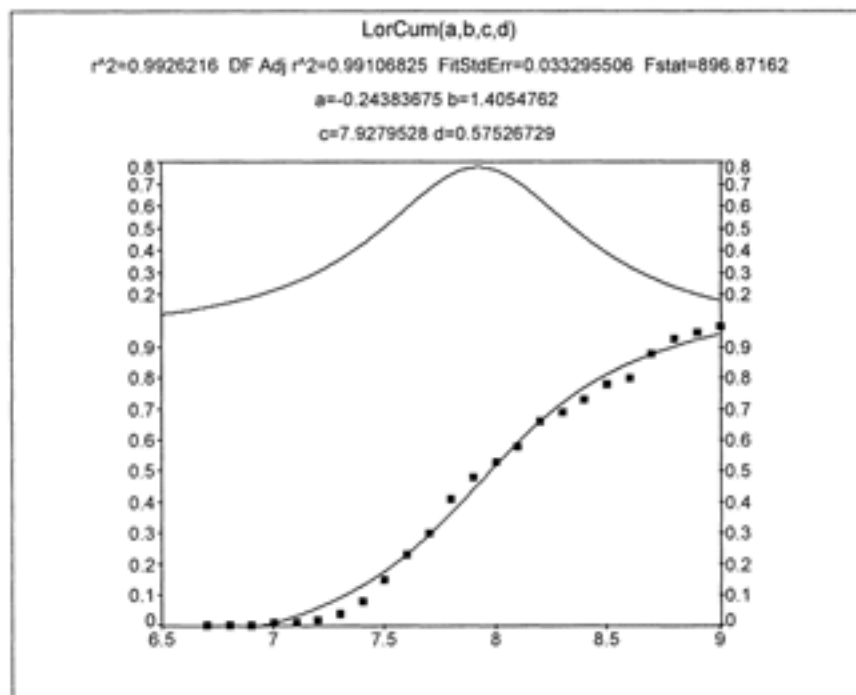
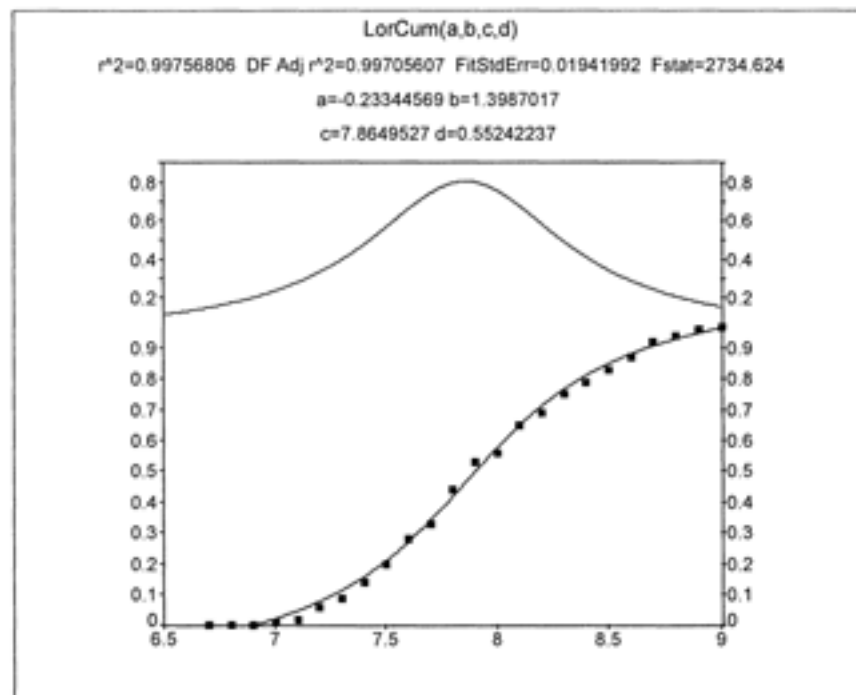
Figures 5-7 and 5-8 show the likelihood of fuel starvation with the wing-end tanks being used. Figure 5-7 shows the likelihood when the effects of the gear in not included and Figure 5-8 when it is included.

By comparing Figures 5-5 and 5-6 where the wing-end tanks are not included it can be seen that the most likely value has risen to 7.93 hours when the gear is not included and 7.86 hours when it is included. Table 5-3 showed that the cumulative likelihood is 58% and 61% based on whether the added fuel consumption due to the gear is included. The Figures are consistent with that information. It can also be seen that the variance is more which can be explained with the added variance with more random variables.

Figure 5-7. Likelihood of fuel starvation as a function of time with the wing-end tanks and no additional fuel consumption due to the gear down.

Figure 5-8. Likelihood of fuel starvation as a function of time with the wing-end tanks and additional fuel consumption due to the gear down.
